Manhole Inspection Summary

Manhole # S33UU_007MH

Insp Date: **4/13/07 11:33 AM**

Location Address: **2912 SAINT PAUL ST**

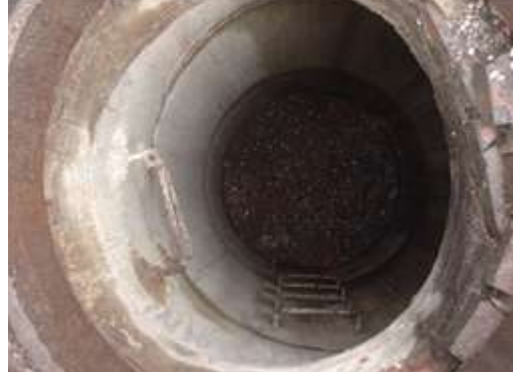
Top View

Channel debris.

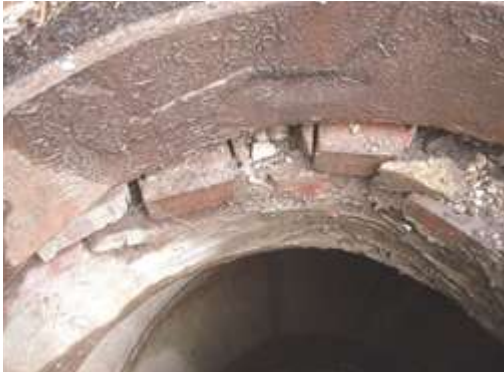
Defect

Frame Offset: **4** (in.)

☒ **Leaks**

Condition: ☐ Sound ☐ Cracked ☐ Root Intrusion ☒ **Loose Brick** ☒ **Deteriorated**

Frame leaks. Frame offset. Adjustment deterioration, loose brick and infiltration. Corbel and Barrel infiltration - other side.

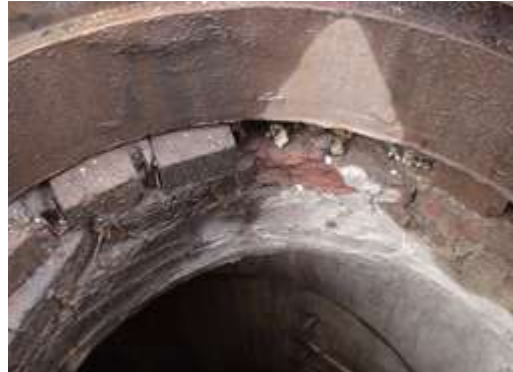
Defect

Frame leaks. Frame offset. Adjustment deterioration, loose brick and infiltration. Corbel and Barrel infiltration.

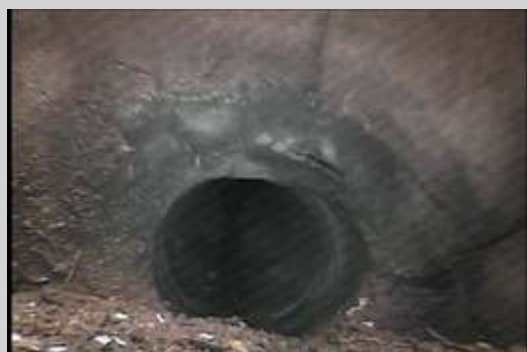
Pipe Out @ 12 O'Clock

Deposits: ☐ None ☒ **Mud** ☐ Sludge ☒ **Debris** ☐ Grease

Deposits Extent: **Light**

Infiltration: **Evidence**
